Investigation of PCC Pavement Sections on I-29 in Pottawattamie County

**Final Report
for
MLR-06-01**

March 2007

**Iowa Department
Of Transportation**

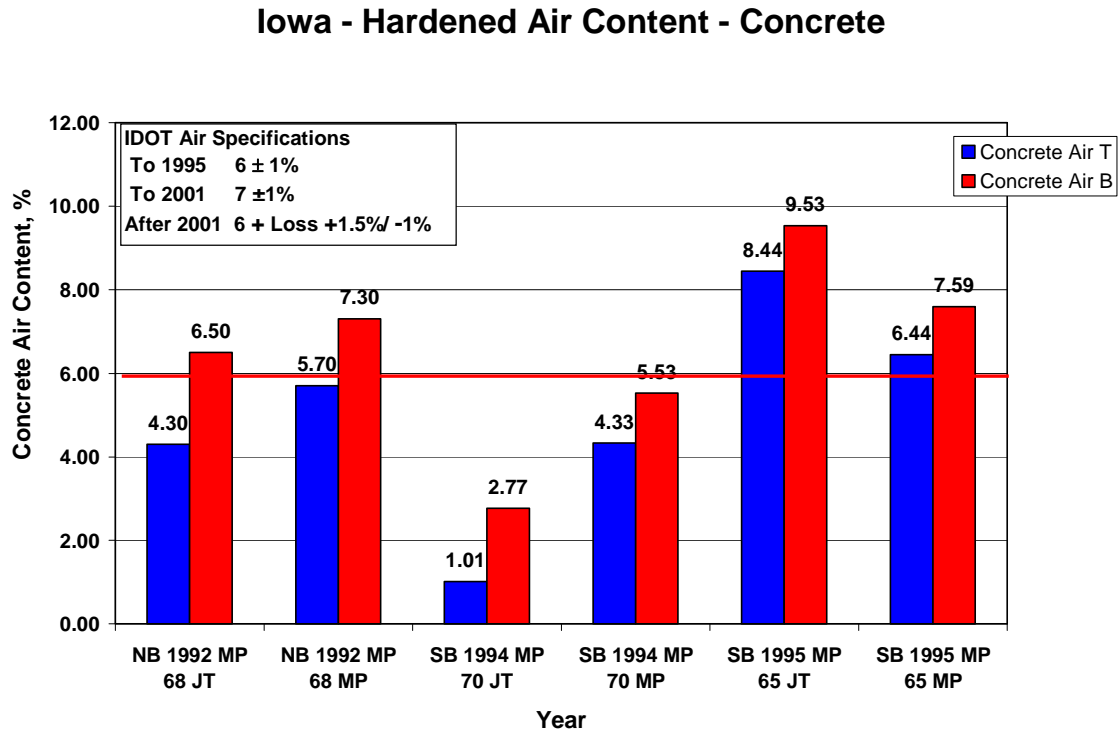
Figure 19 Hardened Air Content in Concrete - I-29

The air content in the top or bottom of 1994 pavement cores at the joint may not be at adequate levels even with a 2% increase in total volume. However, if the air content in the in the top of 1992 pavement cores would have been adequate initially with a 2% increase in total volume, then the air void system may have been compromised by increased saturation and freeze thaw damage, perhaps due to micro-cracking near the surface.

The concrete air contents, mortar air contents, and spacing factors are plotted on figures 19-21.

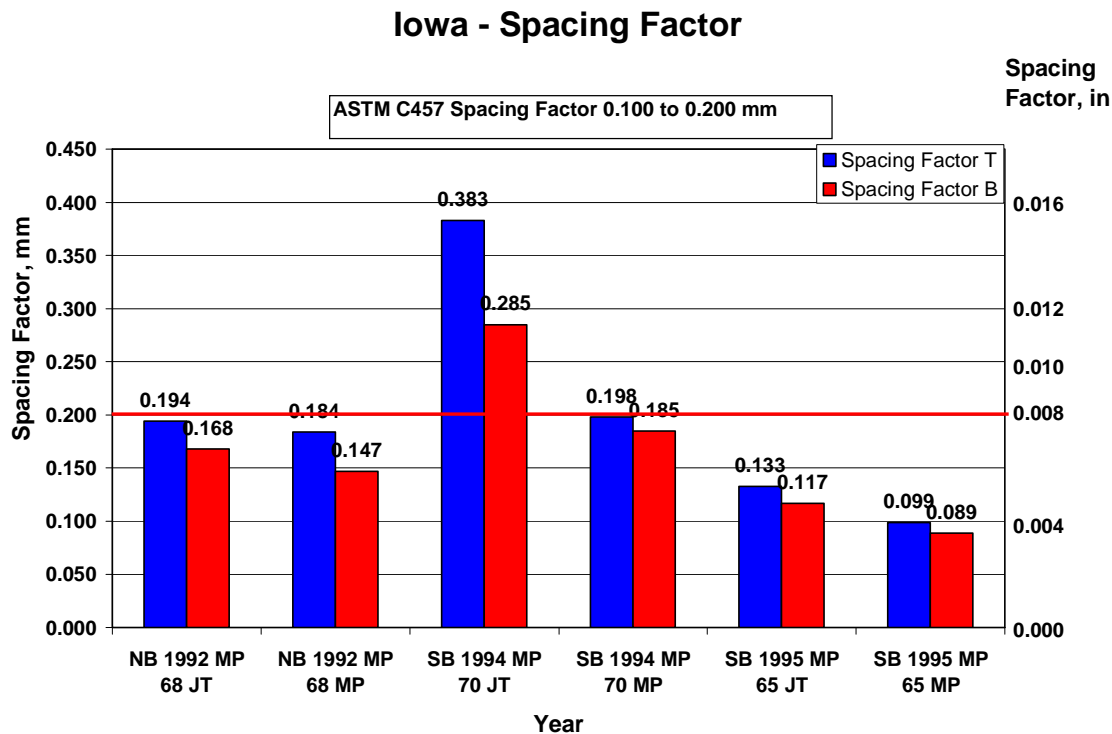
Figure 21. Hardened Air - Spacing Factor I-29

Since the expanding water due to freezing cannot travel more than 0.01 inches (0.2mm) in the paste, the bubbles should be small and relatively close together. ASTM C457 recommends a maximum spacing factor of 0.1 to 0.2 mm (0.004 to 0.008 in) for a severe freeze thaw environment. The spacing factors in the top of the cores obtained at the joint in the 1992 pavement (0.194 mm (0.076 in)) is border line to provide freeze thaw durability. The spacing factors in the top of the cores obtained at the joint in the 1994 pavement (0.383mm (0.0151 in)) is completely inadequate to provide freeze thaw durability. The spacing factor at the top of the cores obtained at the joint in the 1995 pavement is lower than required at 0.133 mm (0.0051 in).
